Report

The impact of the 2023-Earthquake on archaeological locations on the Syrian coast

March 3, 2023

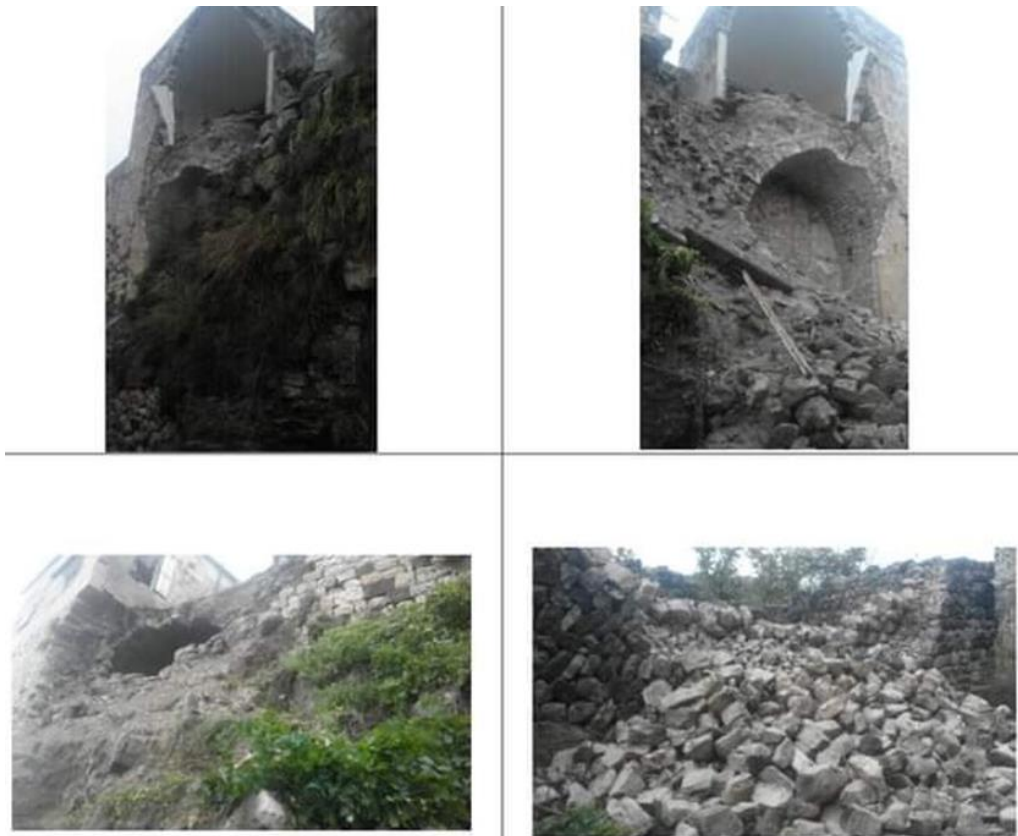
Al-Khawabi Castle

However, the castle has suffered damages resulting from an earthquake, which include the collapse of a section of the upper castle (Haret al-Aghawat) and the basements supporting damaged upper structures. Additionally, there are cracks from the inside and clay fragments crumbling from the walls of the Citadel Mosque, along with the collapse of parts of the remaining ancient village walls.

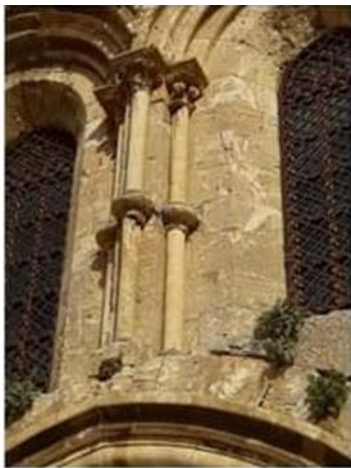
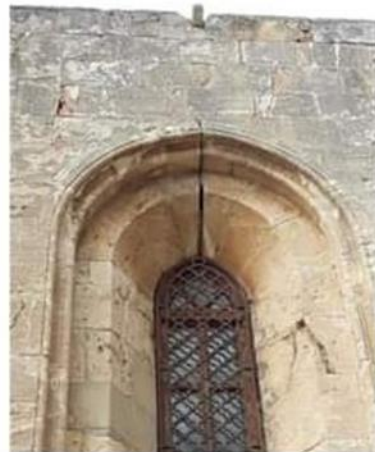
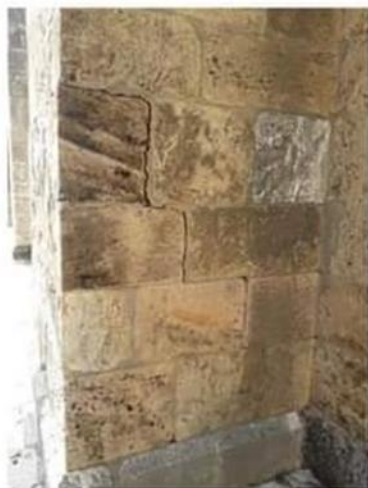
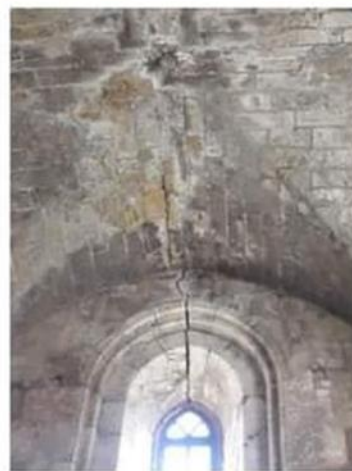
Tartus Cathedral (Tartous Museum)

Unfortunately, the recent earthquake that struck Syria and Turkey on February 6th, 2023, has caused damages to the Tartus Cathedral. Specifically, an old crack in the interior window to the right of the entrance has significantly expanded. There are also dangerous cracks in the decorative columns of the windows above the entrance, along with new cracks appearing in the museum's southern facade.

The situation calls for immediate attention and repair to prevent further harm to the Tartus Cathedral, which holds significant historical and religious value.

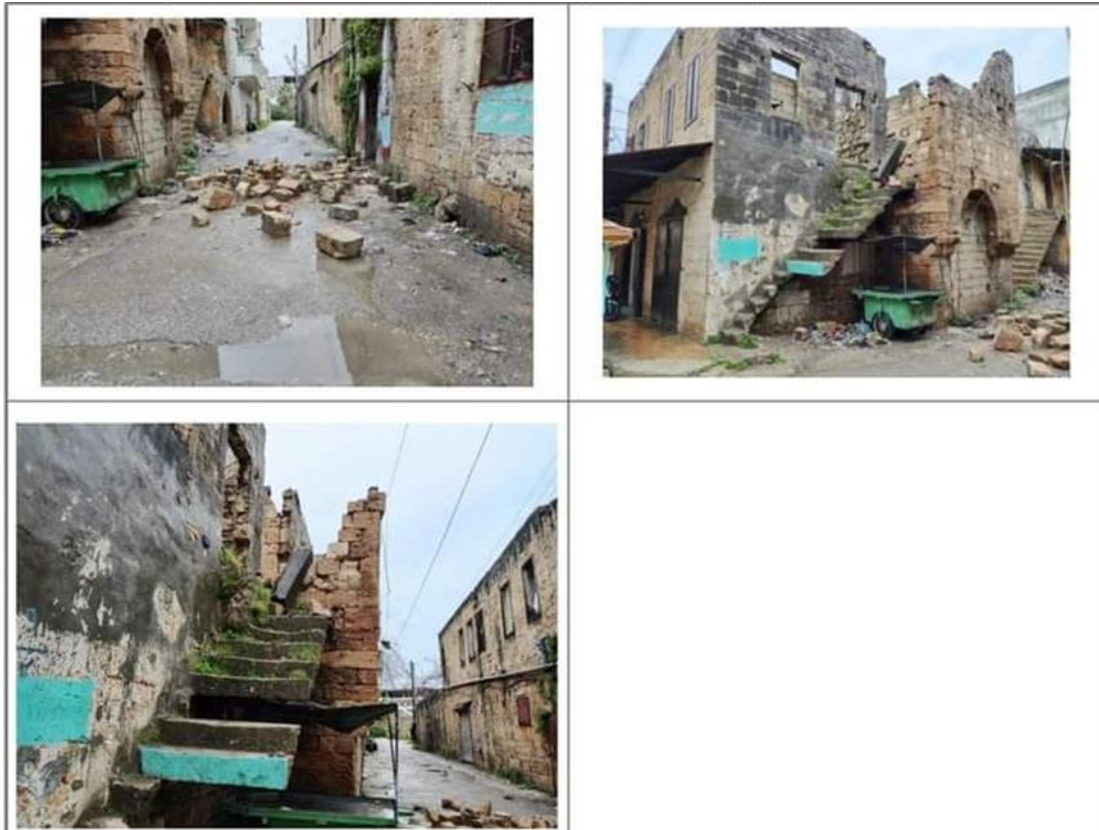
Historical slide in Banias:

Unfortunately, the recent earthquake that struck Syria and Turkey on February 6th, 2023, has caused damages to the city of Banias. One of the damages includes the collapse of a wall and parts of the second floor in estate 157. Further damages include cracks and fissures found in property 143, along with cracks and collapse in the ceiling of the second floor in property 150.

The extent of the damages and their impact on the structures and the city's historical significance is yet to be fully assessed. Urgent attention and repair are necessary to prevent further harm to the city's heritage and cultural sites.

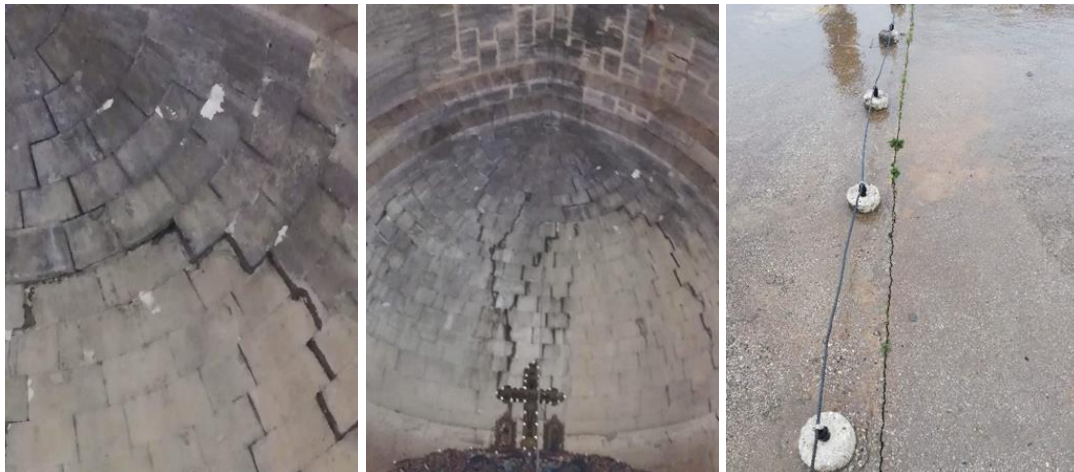
Safita Tower

Unfortunately, the recent earthquake that struck Syria and Turkey on February 6th, 2023, has caused damages to the Safita Tower. The damages include the enlargement of some old cracks and the appearance of new cracks in several places. Additionally, some parts of the stones have collapsed, and a cavity has appeared on the first floor. Moreover, the lightning arrester has been broken.

The extent of the damages and their impact on the tower's structural integrity and historical significance is yet to be fully assessed. Urgent attention and repair are necessary to prevent further harm to the tower and its cultural and historical value.

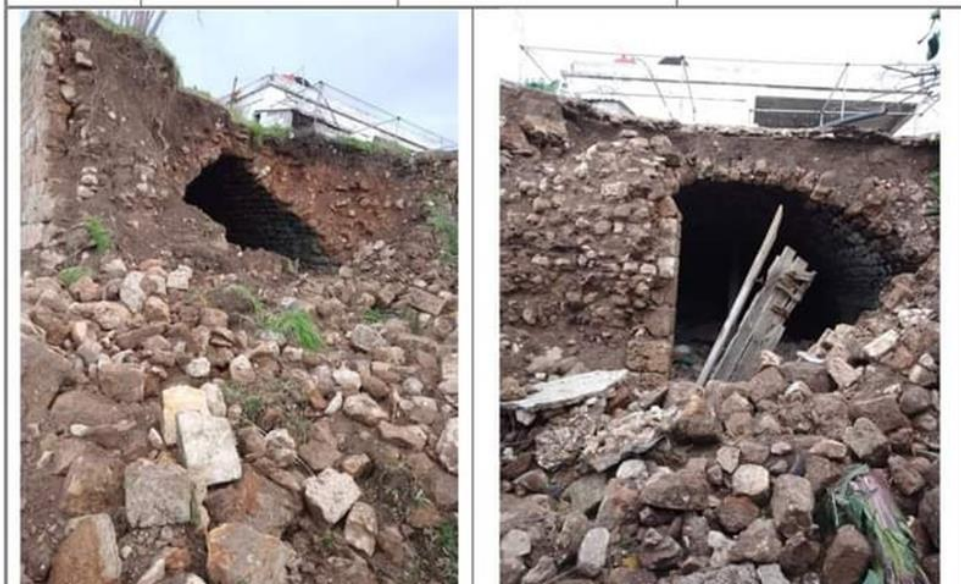
Samarian Khanes:

The damages include the collapse of a section of the remaining cellars.

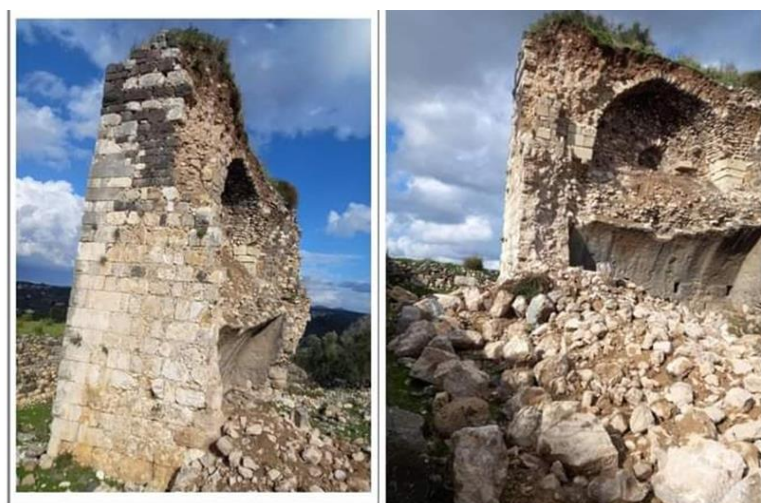
Umm Hosh Tower

The damages include the collapse of the remaining parts of the tower.

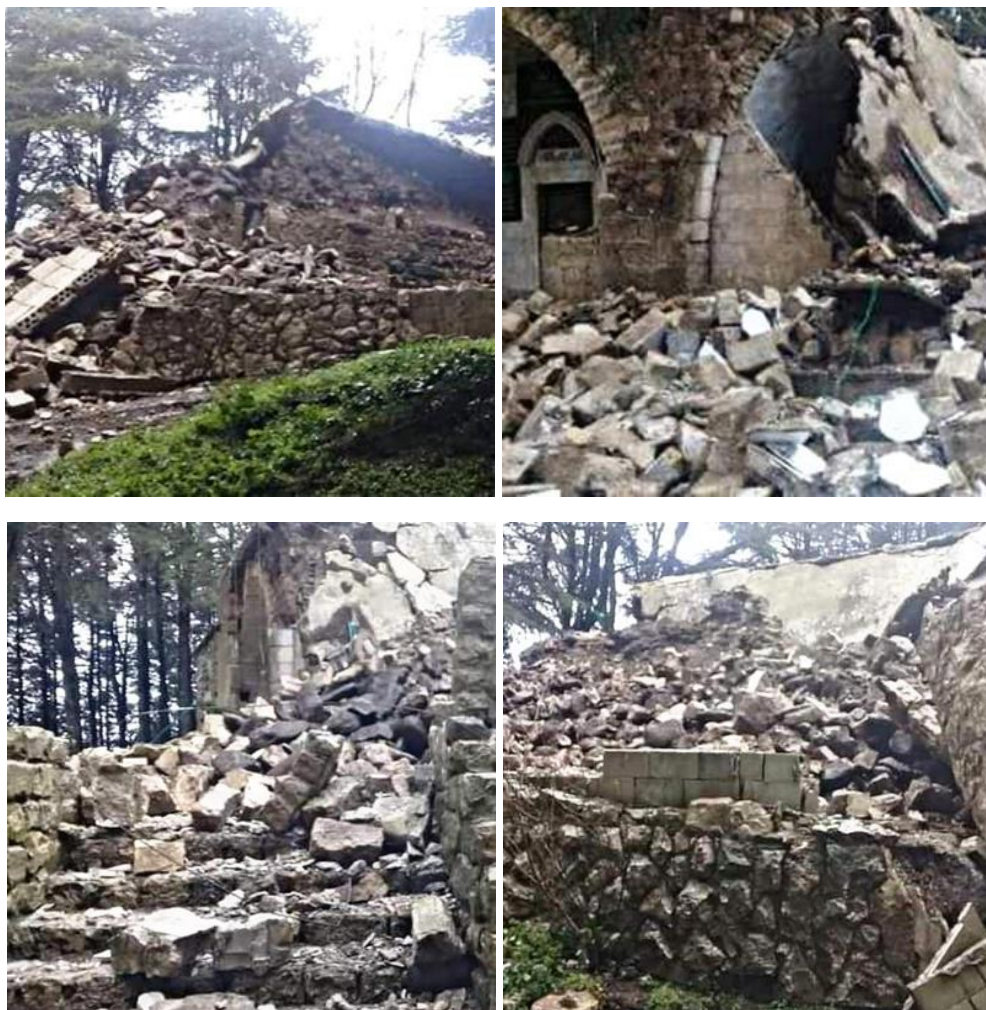
The shrine of Mawla Hassan

Located at an altitude of 1150m, east of the town of Al-Qadmus, amidst a picturesque forest of cedar and cypress trees, is the shrine of Mawla Hassan, also known as Imam Hassan bin Nizar. Mawla Hassan was born in 470 AH and passed away in 537 AH. Unfortunately, the shrine has suffered significant damage with a large portion collapsing.

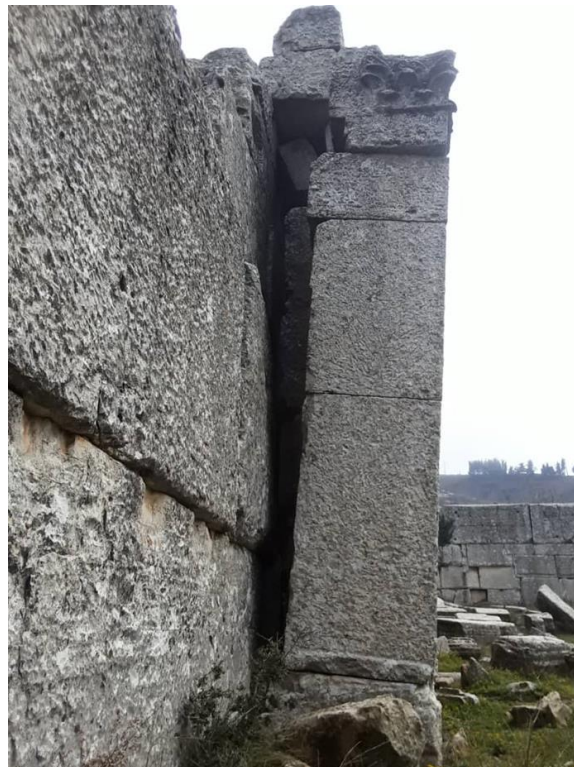
Hosn Suleiman

- The northern gate of the Great Temple has suffered from shifted stones and some of them have fallen.

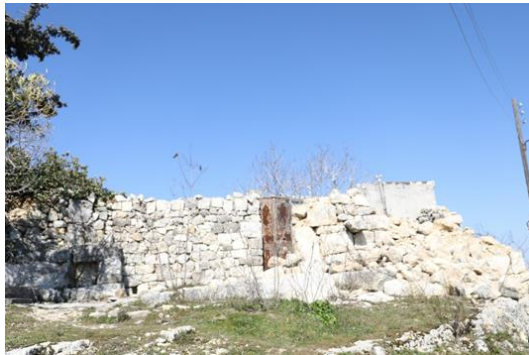
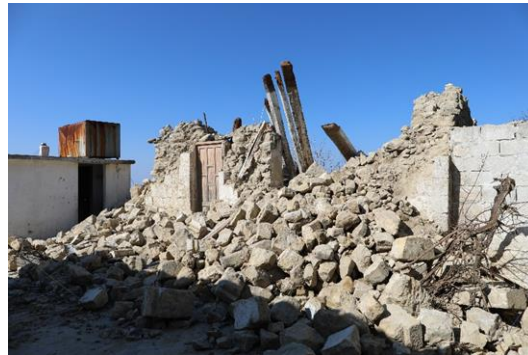
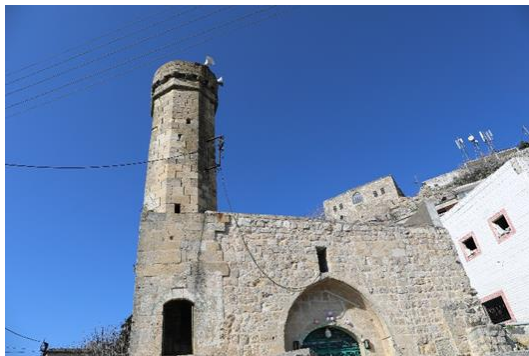
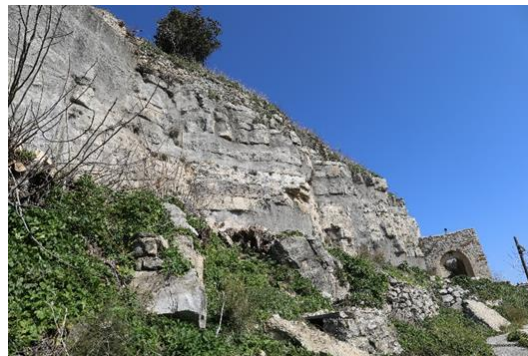
Al-Qadmous Castle

- Significant collapse of the castle buildings and imminent risk of collapse of other parts.
- One of the walls of the Sinan Rashid al-Din shrine has collapsed.
- Stones have fallen from the arch of the main entrance to the castle.
- Some stones have fallen from the rocky cliff supporting the castle.
- There is a serious crack in the minaret of the ancient mosque

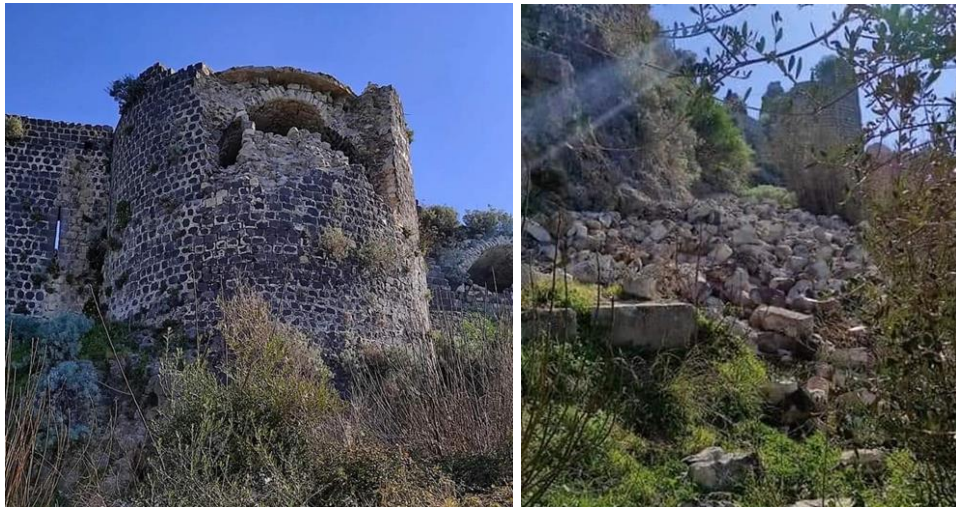
Al-Marqab Castle

- A part of the western façade in the second tower, north of the main gate, has collapsed.
- There is a crack in the southwestern corner of the main gate tower.
- Part of the roof and wall in the eastern pavilion has collapsed.
- Some walls on the roof of the southern Qalawun Tower have partially collapsed.
- There are cracks on both sides of the tower adjacent to the eastern gate.
- There are scattered collapses in the residential village and the inner wall.
- The entire water drainage channel south of the church has collapsed.
- Parts of the walls of the buildings located north of the Ottoman Khan have collapsed.
- The north furnace chimney in the furnace hall has partially collapsed.
- The wall at the top of the donjon tower has partially collapsed, with cracks and displacement on the western side.

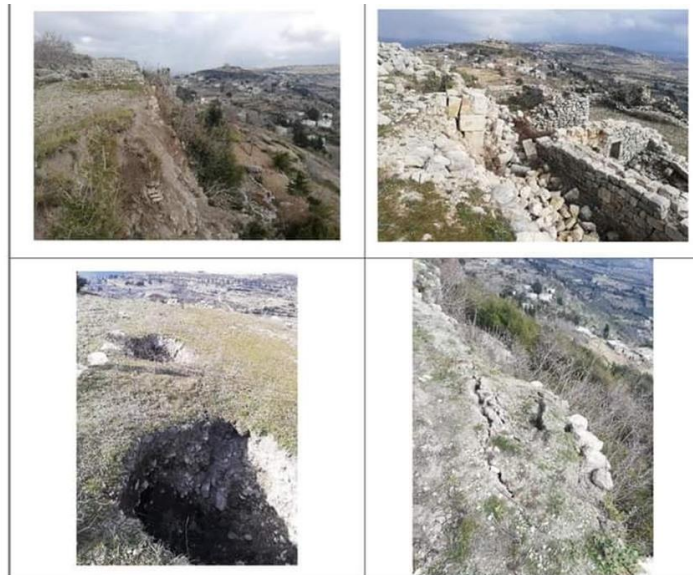
Al-Aleqa Castle

- A crack has been detected in the rocky cliff that supports the castle.
- Partial collapses have been observed in the southern wall of the castle, with adjacent cracks.
- Part of the upper vaults have collapsed, and cracks have appeared in other vaults.
- Part of the eastern vault near the castle entrance has collapsed, with visible cracks in the surrounding area.
- Part of the northern tower of the castle has collapsed.

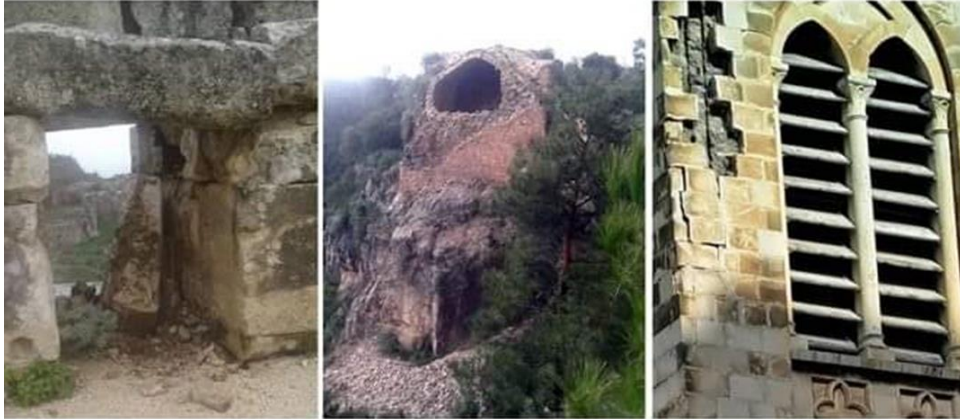
Salah al-Din Citadel

- There are serious cracks in several towers and walls.
- One of the towers on the western side has partially collapsed.
- Stones have fallen from the Royal Tower

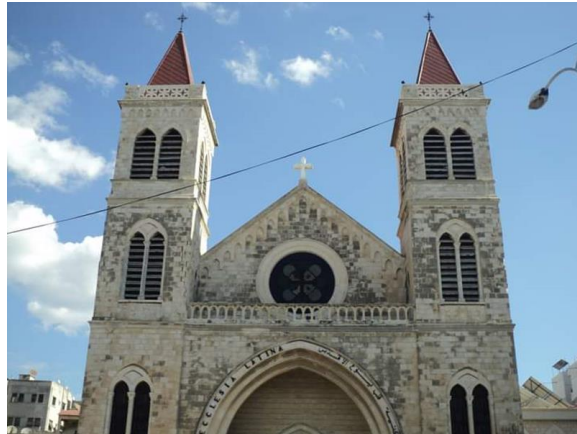
Latin Church

The old church in Lattakia was constructed in 1933 AD. However, it has suffered damages including cracks in the church towers and some fallen stones.

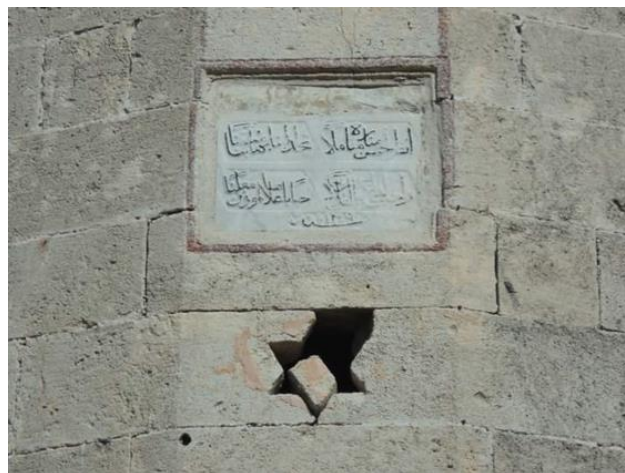
Al Jadid" Mosque

- Cracks have been observed in the minaret structure.
- Some of the decorative elements have been damaged.

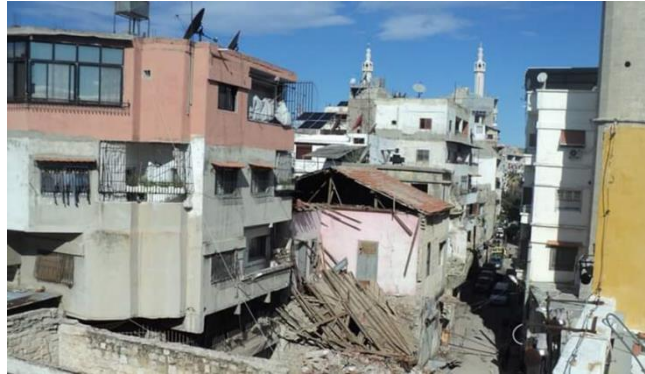
Al-Ajan Palace

The archaeological palace, which dates back to the second half of the nineteenth century AD, is an important site in Lattakia. However, it has been damaged and the entire southern section has collapsed.

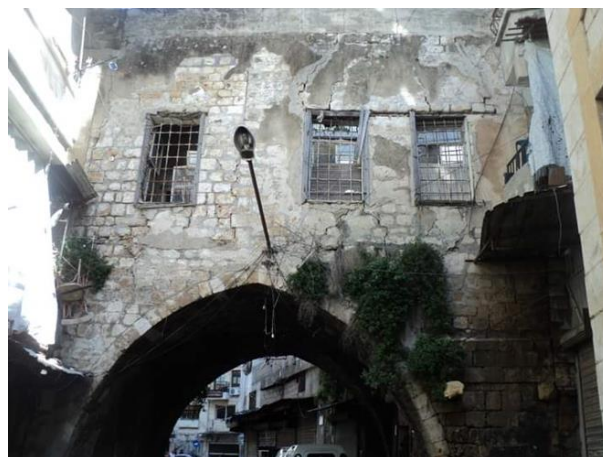
Aouina Bridge

- A significant portion of the roof has collapsed.
- An increase in cracks and fissures has been observed.
